ASBESTOS CONTAINING MATERIAL LOCATIONS - BASEMENT
 HOUSING AUTHORITY OF KANSAS CITY, MISSOURI
 3822 SUMMIT STREET
 KANSAS CITY, MISSOURI 64111

EXHIBIT
3

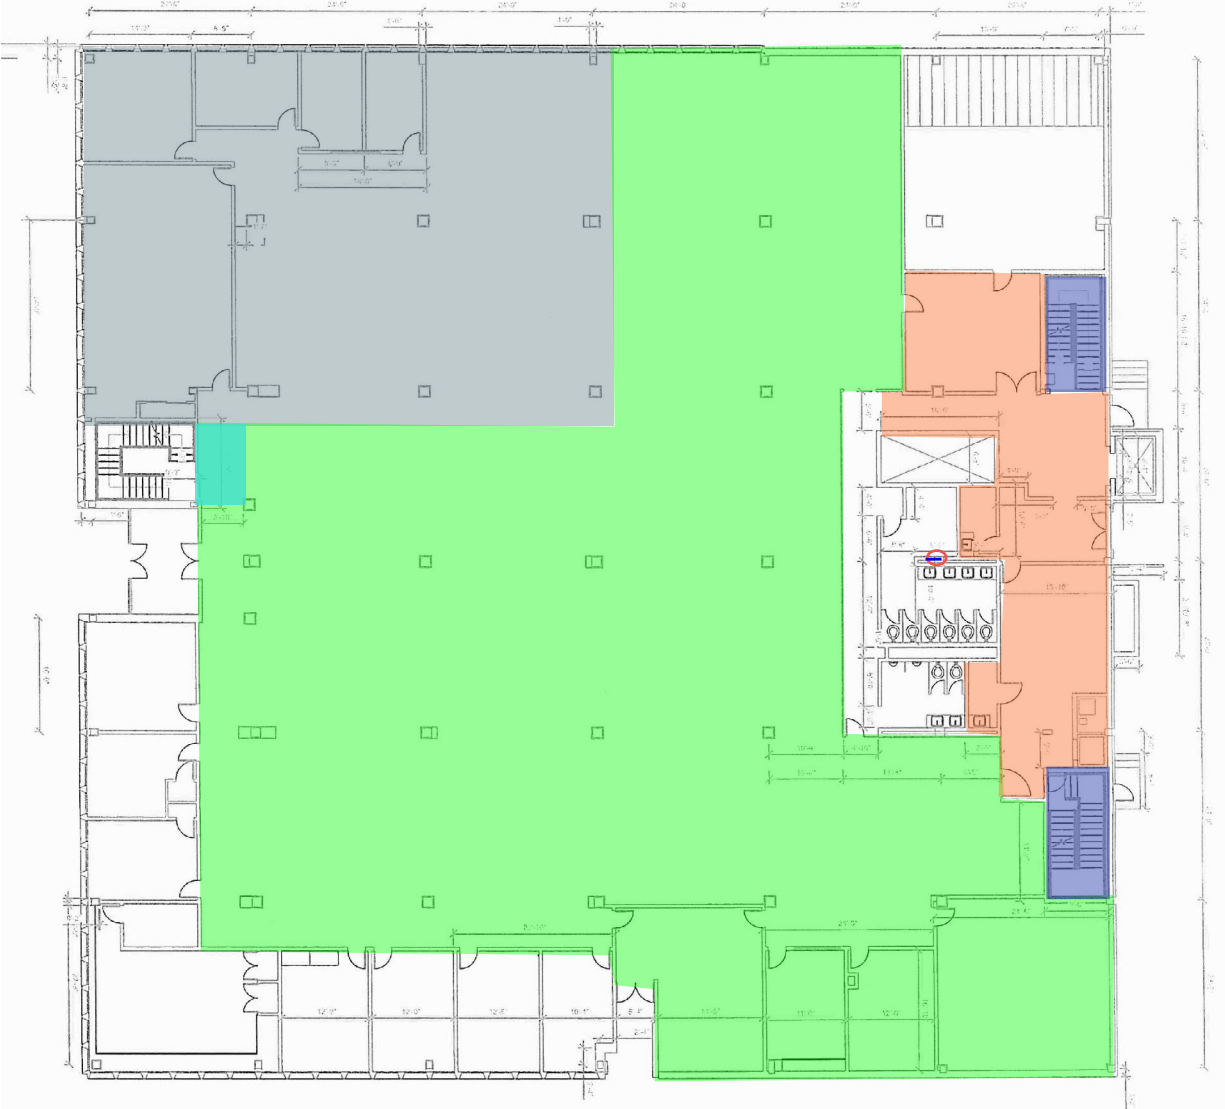
ASBESTOS CONTAINING MATERIAL LOCATIONS - 1ST FLOOR
 HOUSING AUTHORITY OF KANSAS CITY, MISSOURI
 3822 SUMMIT STREET
 KANSAS CITY, MISSOURI 64111

-   Mudded Joint Packings on Non Asbestos Fiberglass Pipe Insulation
-   9" x 9" White with Black Floor Tile and Mastic Beneath Carpet
-   9" x 9" Black with White Floor Tile and Mastic and Black with White Stair Tread
-   12" x 12" Black Mastic Beneath 12" x 12" Tan Floor Tile
-   Black Mastic Beneath Carpet
-   Acoustic Plaster

NOTE:
 PIPE END SEALANTS ARE PRESENT IN SCATTERED LOCATIONS ABOVE DROP CEILING ON ALL FLOORS.
 ADDITIONAL QUANTITIES OF Mudded JOINT PACKINGS MAY BE PRESENT HIDDEN IN WALLS, COLUMNS, CEILING AND VOIDS.
